# **Integrated structural safety analysis of San Francisco Master Gate in the Fortress of Almeida**

*Abstract* – After more than three hundred years of being exposed to human and nature actions the Master Gate of San Francisco in Almeida, Portugal, has sustained visible extended damage. Although its importance, as a historical monument, is undeniable, no attempts have been done so far to determine its level of safety. In this paper several models are developed in order to achieve this goal. A brief description of the Gate's history is presented followed by a summary of the inspection and diagnosis procedures employed in this study and the results obtained from them. Later the type of numerical models selected are discussed as well as the methodologies used to represent damage. Finally results from the numerical models are presented in a first attempt to identify the safety level of this historic construction. Results indicate that although the structure has lost a great percentage of its original capacity is still safe.

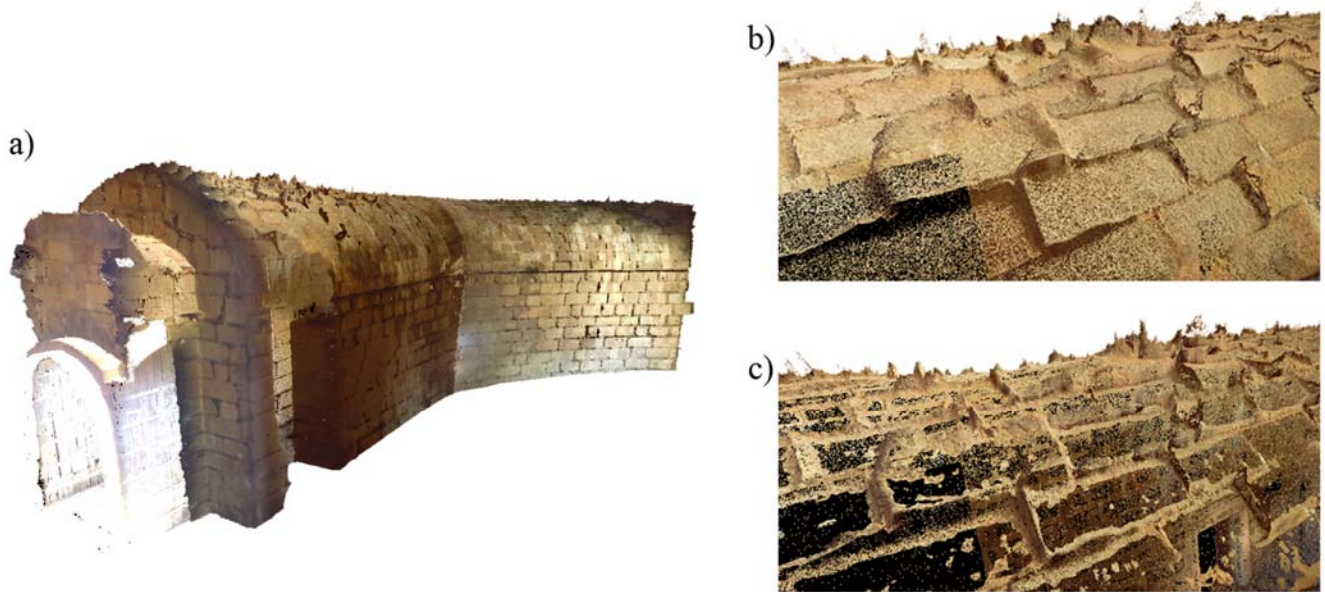
Figure 9. Point cloud obtained during the TLS campaign: (a) isometric view of the barrel vault; (b) detail at full resolution of the barrel vault; and (c) detail of the resampled vault point cloud.

The loss of material in the joints between the voussoir stones seems severe, according with the results provided by the TLS point cloud (Figure 9). A number of 28 2D sections extended through the tunnel depicts precisely the loss of material in each joint (Figure 14a). The profiles from the area close to the

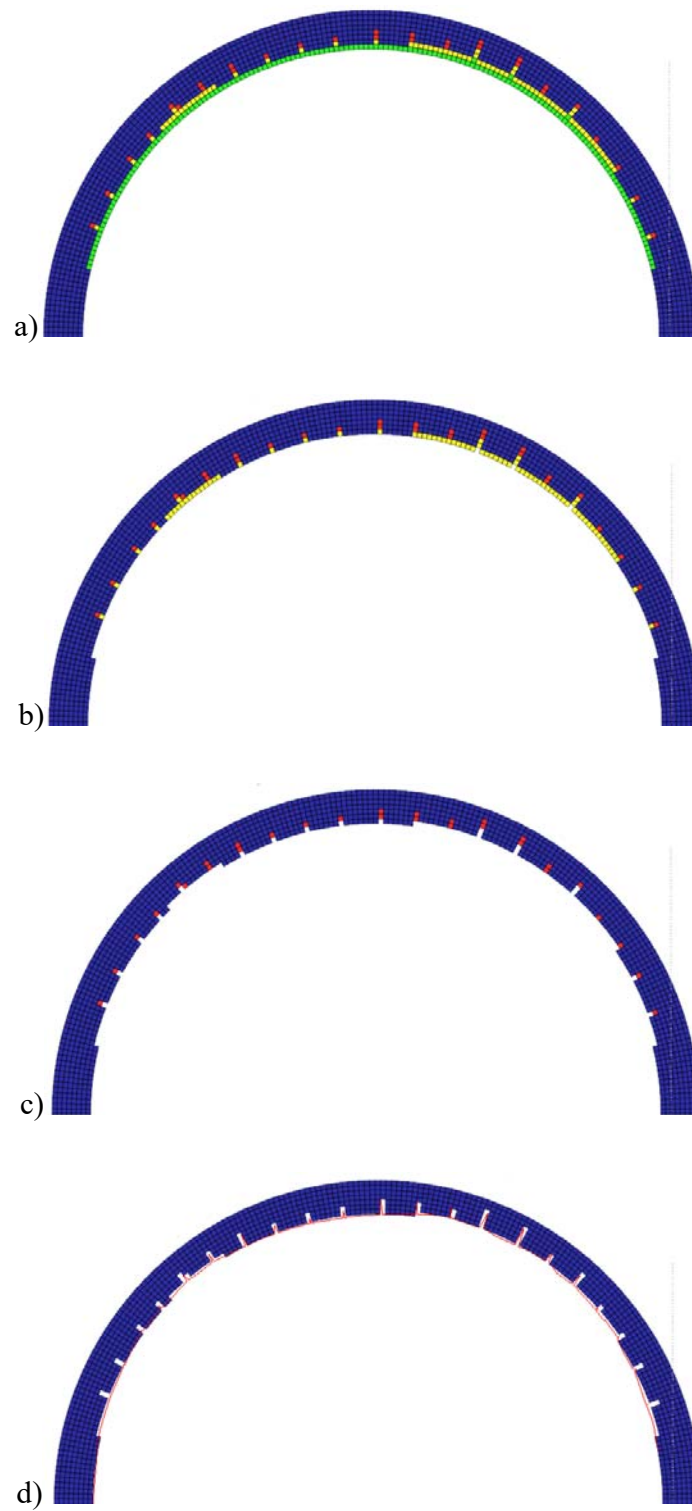
Figure 18a shows the mesh refinement in the vault over the entrance, while Figure 18 b, c and d show the step by step removal of elements till the actual level of damage (last step), this same picture includes the 2D diagram representing the damage according to the TLS survey presented in Section 3.1.1. Notice how the mesh has been accommodated to follow, as truth as possible, the line of damage in the vault.

Figure 18. Refinement of the mesh in the right vault: a) Complete mesh for the right vault; b) Mesh after the removal of the first group of elements; c) Mesh after the removal of the second group; and d) Removal of all non existing elements and actual state of deterioration of the vault.

The first step implies the removal of the most exterior layer of elements in the intrados of the vault (Figure 18b). This results in a higher concentration of compressive stresses in the vault and a general reduction of the maximum load the structure can resist. Load factor decreases from 49.0 to 40.1 (Figure 26), which represents around 20% of loss in the structure's ultimate capacity due to a general loss of material of 5 cm in the intrados of the vault (12.5% of the thickness). Figure 23 shows the compressive zones in the base of the vault where the crushing of the material occurs. Note that the compressed zones are not focalized but evenly distributed along the intrados base of the vault.

By removing the second section of elements (Figure 18c), the ultimate factor lowers a total of 40%. Almost half the capacity of the structure has been lost at this stage and this model does not even represent the current level of damage. Anyway the load factor has lowered to 29.2 which is still extremely high, indicating that even though half the capacity has been lost the structure is still safe. Figure 24 shows the principal compressive stresses for this load factor. The biggest change in comparison with the previous step is the concentration of compressive stresses on much localized areas in both the left and right on the top of the vault.

In the final step the removed elements (Figure 18d) leave a structure that resembles the most the current state of deterioration. A high compressive hinge is clearly formed on the top right of the vault (Figure 25), where crushing of the material would most likely occur. The load factor has decreased from 49 to 23 resulting in a loss of capacity of 53%. Even in these conditions the structure can be considered safe, as the load factor of 23 represents a loading condition of 23 times 5 kN/m<sup>2</sup>, which equals to 115k N/m<sup>2</sup>.

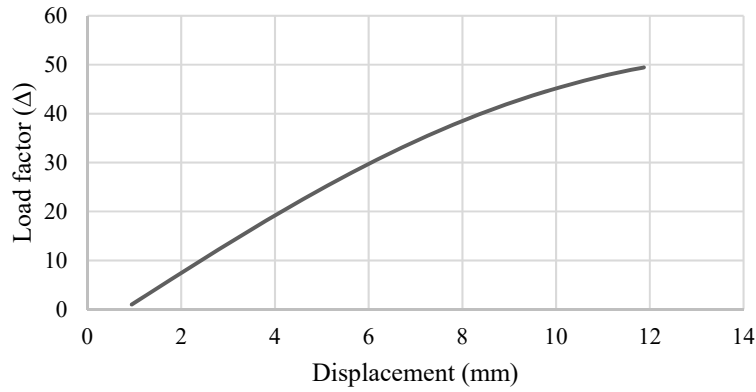
Figure 19 shows the displacement of the control point against the live load factor. The nonlinear behavior starts to be evident when the load factor reaches the value 30 (100% of the self-weight and a live load of  $150 \text{ kN/m}^2$ ). From this point, the structure shows a non-linear behavior until failure, at load factor equal 49 times the live load (100% of the self-weight and a live load of  $245 \text{ kN/m}^2$ ).

Figure 19. Load displacement diagram of the original structure for incremental of live load

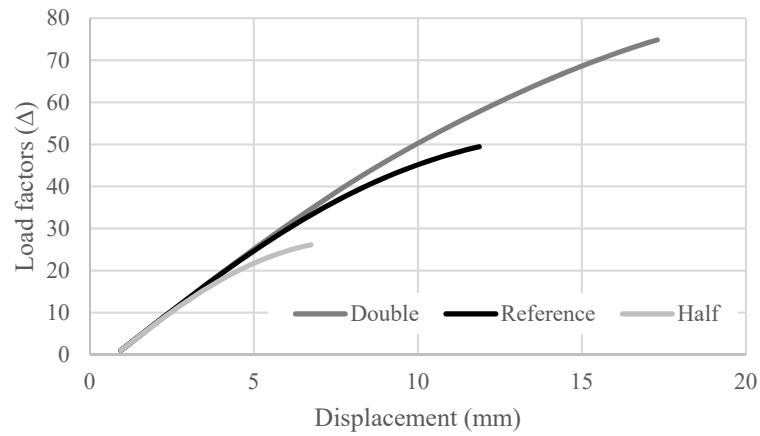
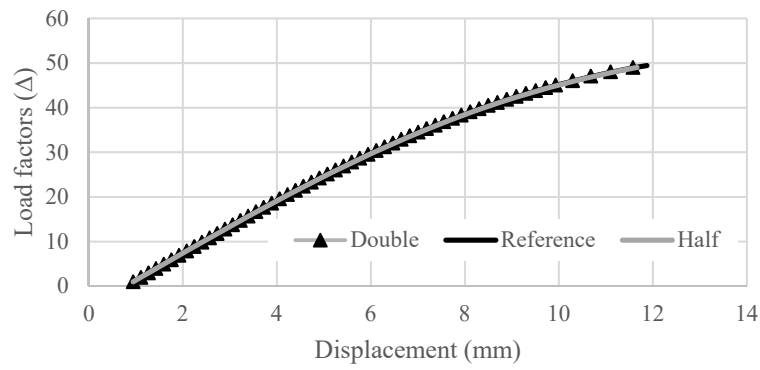
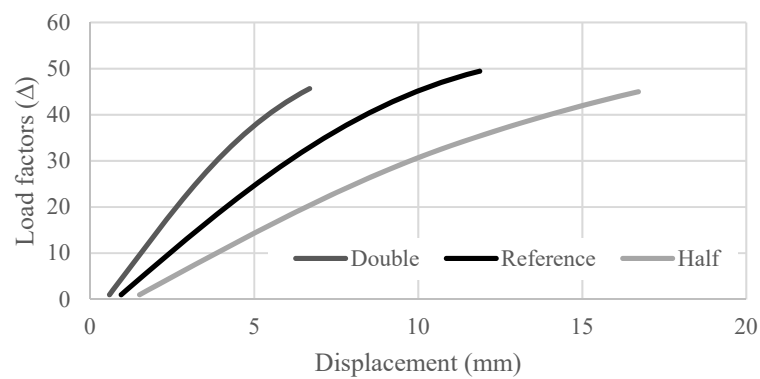
Figure 12 presents the overall influence of the different parameters: compressive capacity, tensile capacity and modulus of elasticity. Notice in Figure 21a how the response of the structure is almost directly proportional to the variation of the compressive strength (and fracture energy) limit of the stone masonry. Duplication of the compressive strength parameter results in an increase in the load factor from 49 to 74 ( $\approx +50\%$ ). A reduction from 49 to 26 ( $\approx -50\%$ ) is obtained when the same property was halved.

Concerning the variation of the tensile strength (and fracture energy) of the material, its influence does not show any relevant effect in the failure history of the material as shown in Figure 21b. For the reference properties the first crack appears in the middle of the intrados at load factor of 11.8, while it develops much earlier at load factor 2.97 for half the tensile strength. Duplication of the tensile capacity resulted in a later observation of cracks, at load factor 29.6. Even though the comparison of history of crack apparition shows that the tensile strength does have a high influence in the formation of cracks, this effect is not reflected in the load history of the whole structure. This result can be interpreted as that the damage in tension is highly smaller than the one in compression. Therefore the structure failure is mainly governed by crushing of the material in compression.

The influence of the Young modulus of the masonry vault is shown in Figure 21c. The results presents a direct change in the slope of the material curves in the load versus displacement diagrams. It is clear that a duplication of the modulus of elasticity results in a higher stiffness as the slope of the curve becomes higher. The structures rigidity is as well diminished after its modulus of elasticity its cut half. It must be noted that, while changing this parameter, the modulus of elasticity of the infill was not altered, which again point out the relevance of the material properties of the stone masonry structure compared to the infill material properties.

Figure 21. Load vs. displacements curves as a result of a variation in the following parameters: a) compressive capacity; b) tensile capacity and c) Modulus of elasticity.

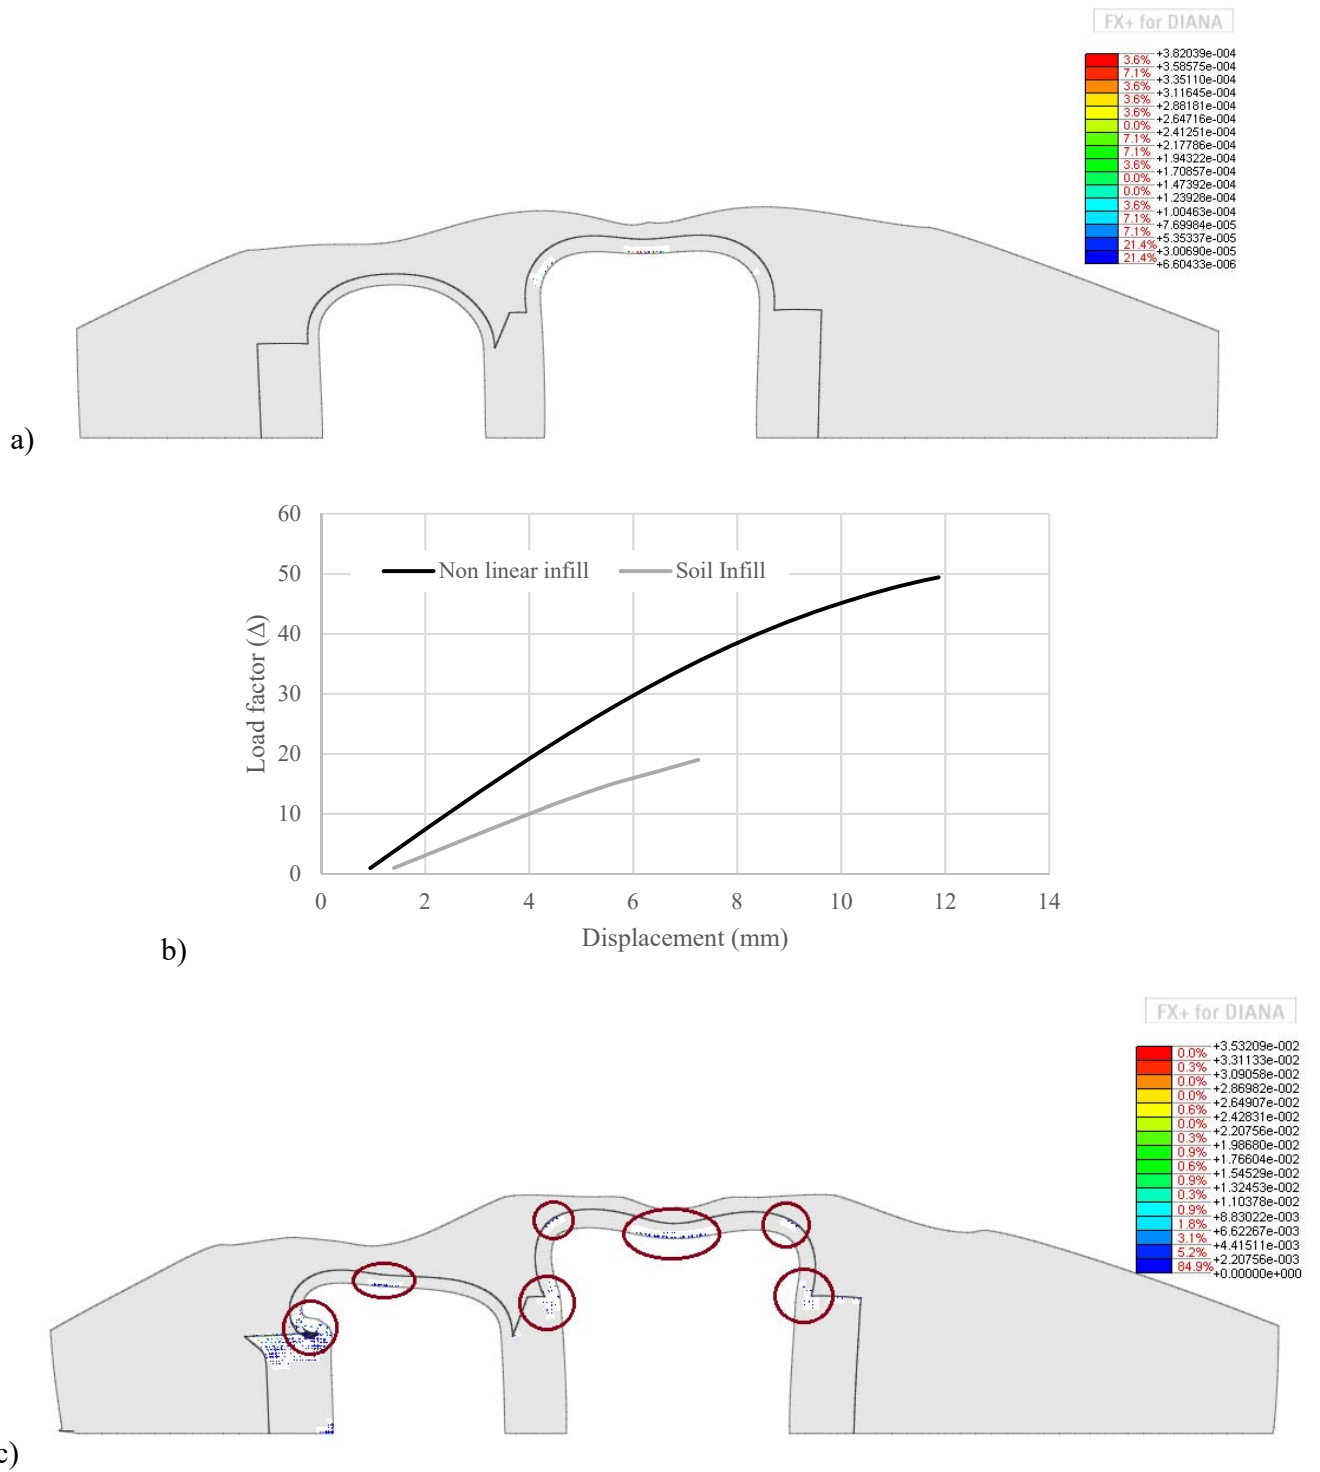
The last sensitivity analysis was devoted to the influence of the soil infill material. The variation of the infill from a nonlinear material to an elastic one did not have a significant impact on the maximum load that the structure could take. The ultimate load factor varied from 49 to 56, which did not represent a large influence relatively to the impact of the variation of properties of the stone masonry. The crack pattern remained the same in the supporting structure while no cracks appear in the infill (see Figure 22a). Second, a different constitutive law was used for the soil using a Mohr-coulomb rule (soil model), where the cohesion was considered equal to 200 kPa, the tangent of friction angle was equal to  $61.6^\circ$ , the same value for the dilatancy angle, and a cap tensile strength equal to 0.02 MPa. For this model, the load factor significant decreases, showing high influence of the soil properties. Figure 22b shows a comparison of the structure's behavior as a result of a change in the infill model. The nonlinear infill modeled with a total strain crack model results in a general higher stiffness for the structure and a higher load factor when compared to the soil model. A value of 49 compared to a value of 18.1. The soil model shows a more clear mechanism of failure (see Figure 22b) which seems to make it a more adequate candidate to use for the study of the structural behavior of the Gate of San Francisco. But there is no certainty of what kind of material is in the infill as there are records that show there have been grout injections in the past.

Figure 22. Sensitivity analysis for the soil infill: a) Crack pattern for elastic infill at the maximum live load factor; b) Comparison of load vs. displacement for a soil infill; and c) Crack pattern for a model with a soil model for the infill.
